Manhole Inspection Summary

Manhole # S41W__034MH

Insp Date: **2/28/08 11:32 AM**

Location Address: **1473 Stevenson Street**

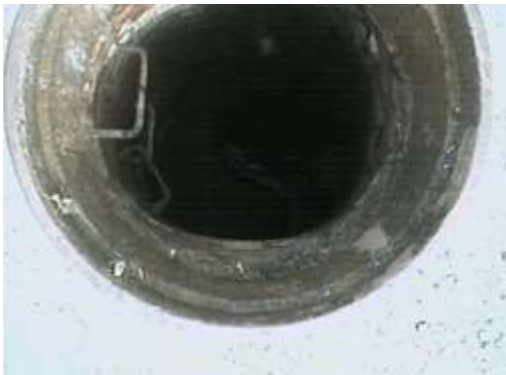
Defect 2

Offset: **2** (in.)

frame offset

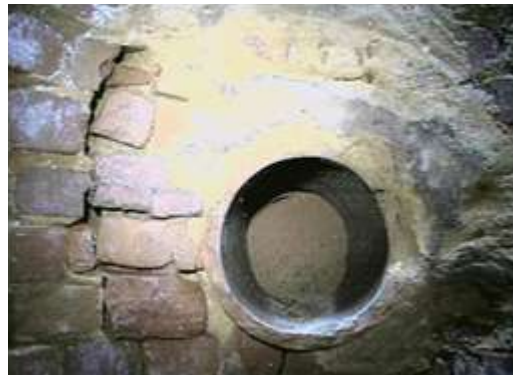
Defect 3

Condition: ☐ Sound ☒ **Cracked** ☐ Root Intrusion ☒ **Loose Brick** ☐ Deteriorated

Barrel cracked and loose bricks

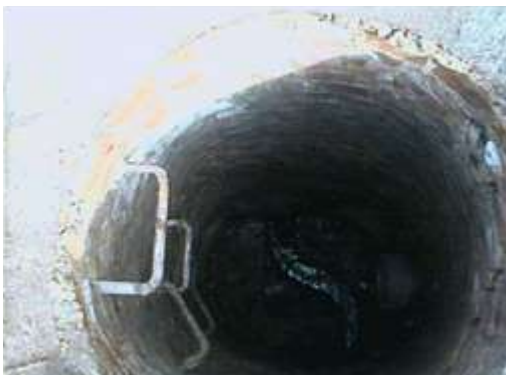
Defect 1

Condition: ☐ Sound ☒ **Cracked** ☐ Root Intrusion ☒ **Loose Brick** ☐ Deteriorated

Count: **7** Missing: **0** ☒ **Corroded**

corroded steps, corbel cracked, loose brick (opposite side from steps)

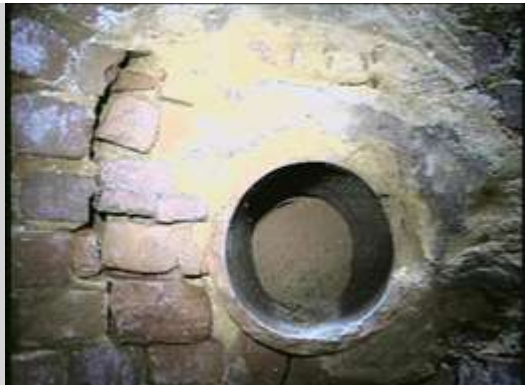
9 O'Clock Inflow

8 in. Circular Gravity Sewer
Pipe In @ 9 O'Clock

Deposits: ☐ None ☐ Mud ☐ Sludge ☒ **Debris** ☐ Grease

Silt Depth: 0 (in.) Deposits Extent: **Heavy**
